City of Portola

Re: Critical Emergency Services Infrastructure- FEMA Project #743764, DR-4699-CA

Critical Infrastructure

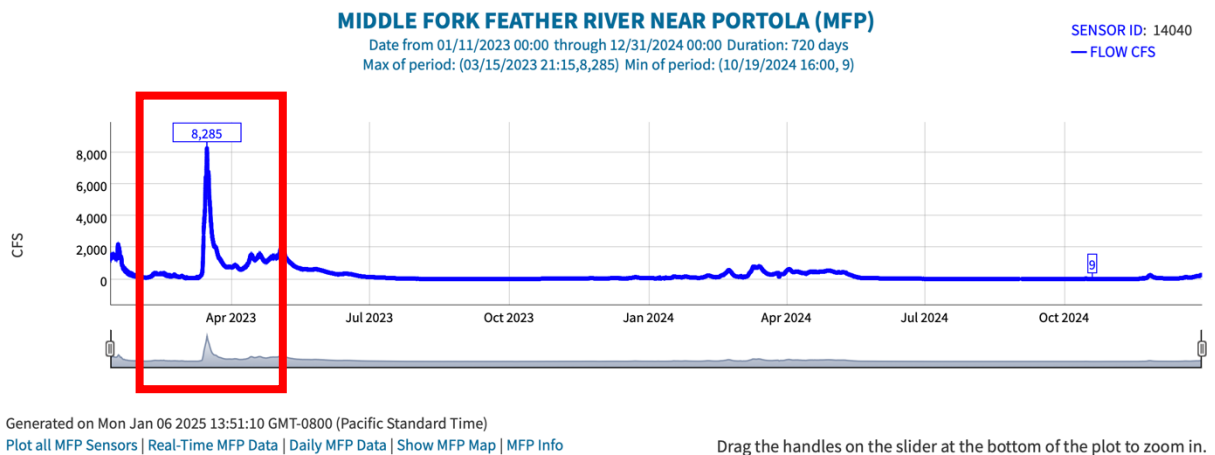
March 2023 Peak Flow

As an additional point of analysis and evidence to the impact of the DR-4699-CA disaster on the bridge, the City has reviewed the MIDDLE FORK FEATHER RIVER NEAR PORTOLA (MFP) historical flow data provided by the California Department of Water Resources. The flow data referenced below indicates a **peak flow of 8,285 CFS during March of 2023**, which aligns with the incident period from DR-4699-CA. We have also provided historical data back to 2018 illustrating normal flows for the river.

While there have historically been instances of increased flow during the spring season, **none of the flow increases from 2018 to 2024 compare to the significant spike experienced in March 2023, which was caused by the winter storm disaster.**

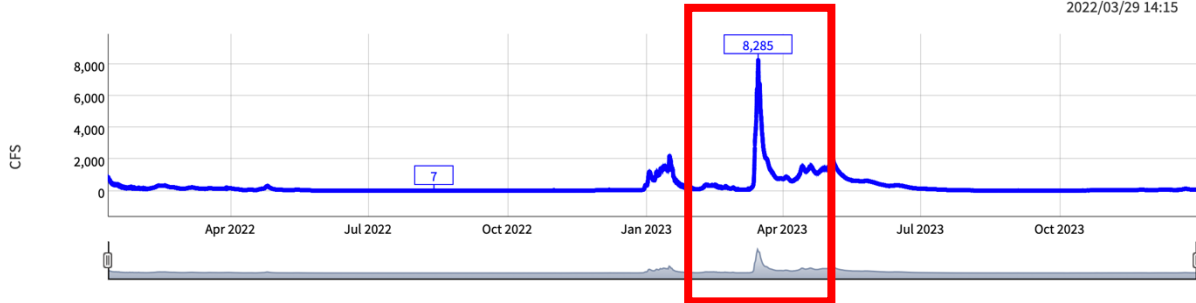
MIDDLE FORK FEATHER RIVER NEAR PORTOLA (MFP)

Date from 01/10/2022 00:00 through 12/31/2023 00:00 Duration: 720 days
Max of period: (03/15/2023 21:15,8,285) Min of period: (08/13/2022 15:30, 7)

SENSOR ID: 14040
— FLOW CFS: 170
DATETIME:
2022/03/29 14:15

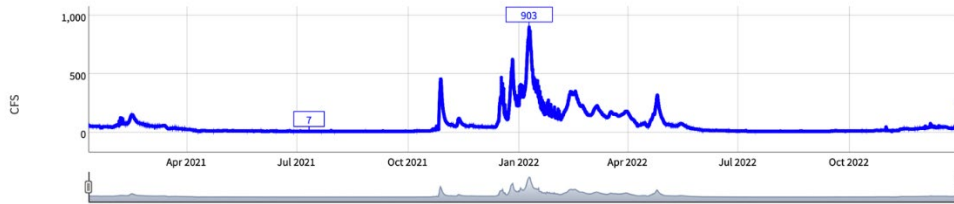
MIDDLE FORK FEATHER RIVER NEAR PORTOLA (MFP)

Historical Flow

Date from 01/10/2021 00:00 through 12/31/2022 00:00 Duration: 720 days
Max of period: (01/09/2022 12:45,903) Min of period: (07/11/2021 15:00, 7)

SENSOR ID: 14040
— FLOW CFS

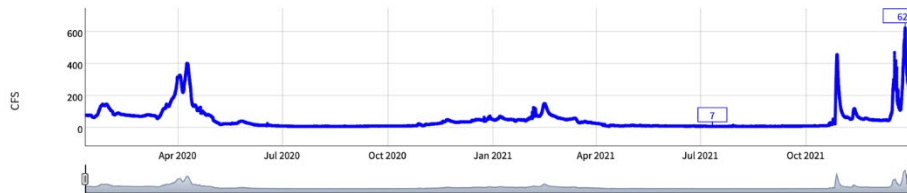
MIDDLE FORK FEATHER RIVER NEAR PORTOLA (MFP)

Date from 01/11/2020 00:00 through 12/31/2021 00:00 Duration: 720 days
Max of period: (12/26/2021 19:15,625) Min of period: (07/11/2021 15:00, 7)

SENSOR ID: 14040
— FLOW CFS
